WASTE PLANT AT ABBOTSLEY – INSPECTION PROGRESS

**Ref: Norwegian Log Chalets Ltd In Administration
Abbotsley – Ground Rent, Services Charges and Sewage Treatment Plant**

Re: Your Letter of 25th November – Sewage Plant at Abbotsley Country Homes

Abbottley
SEWAGE TREATMENT PLANT
1:200 @ A3

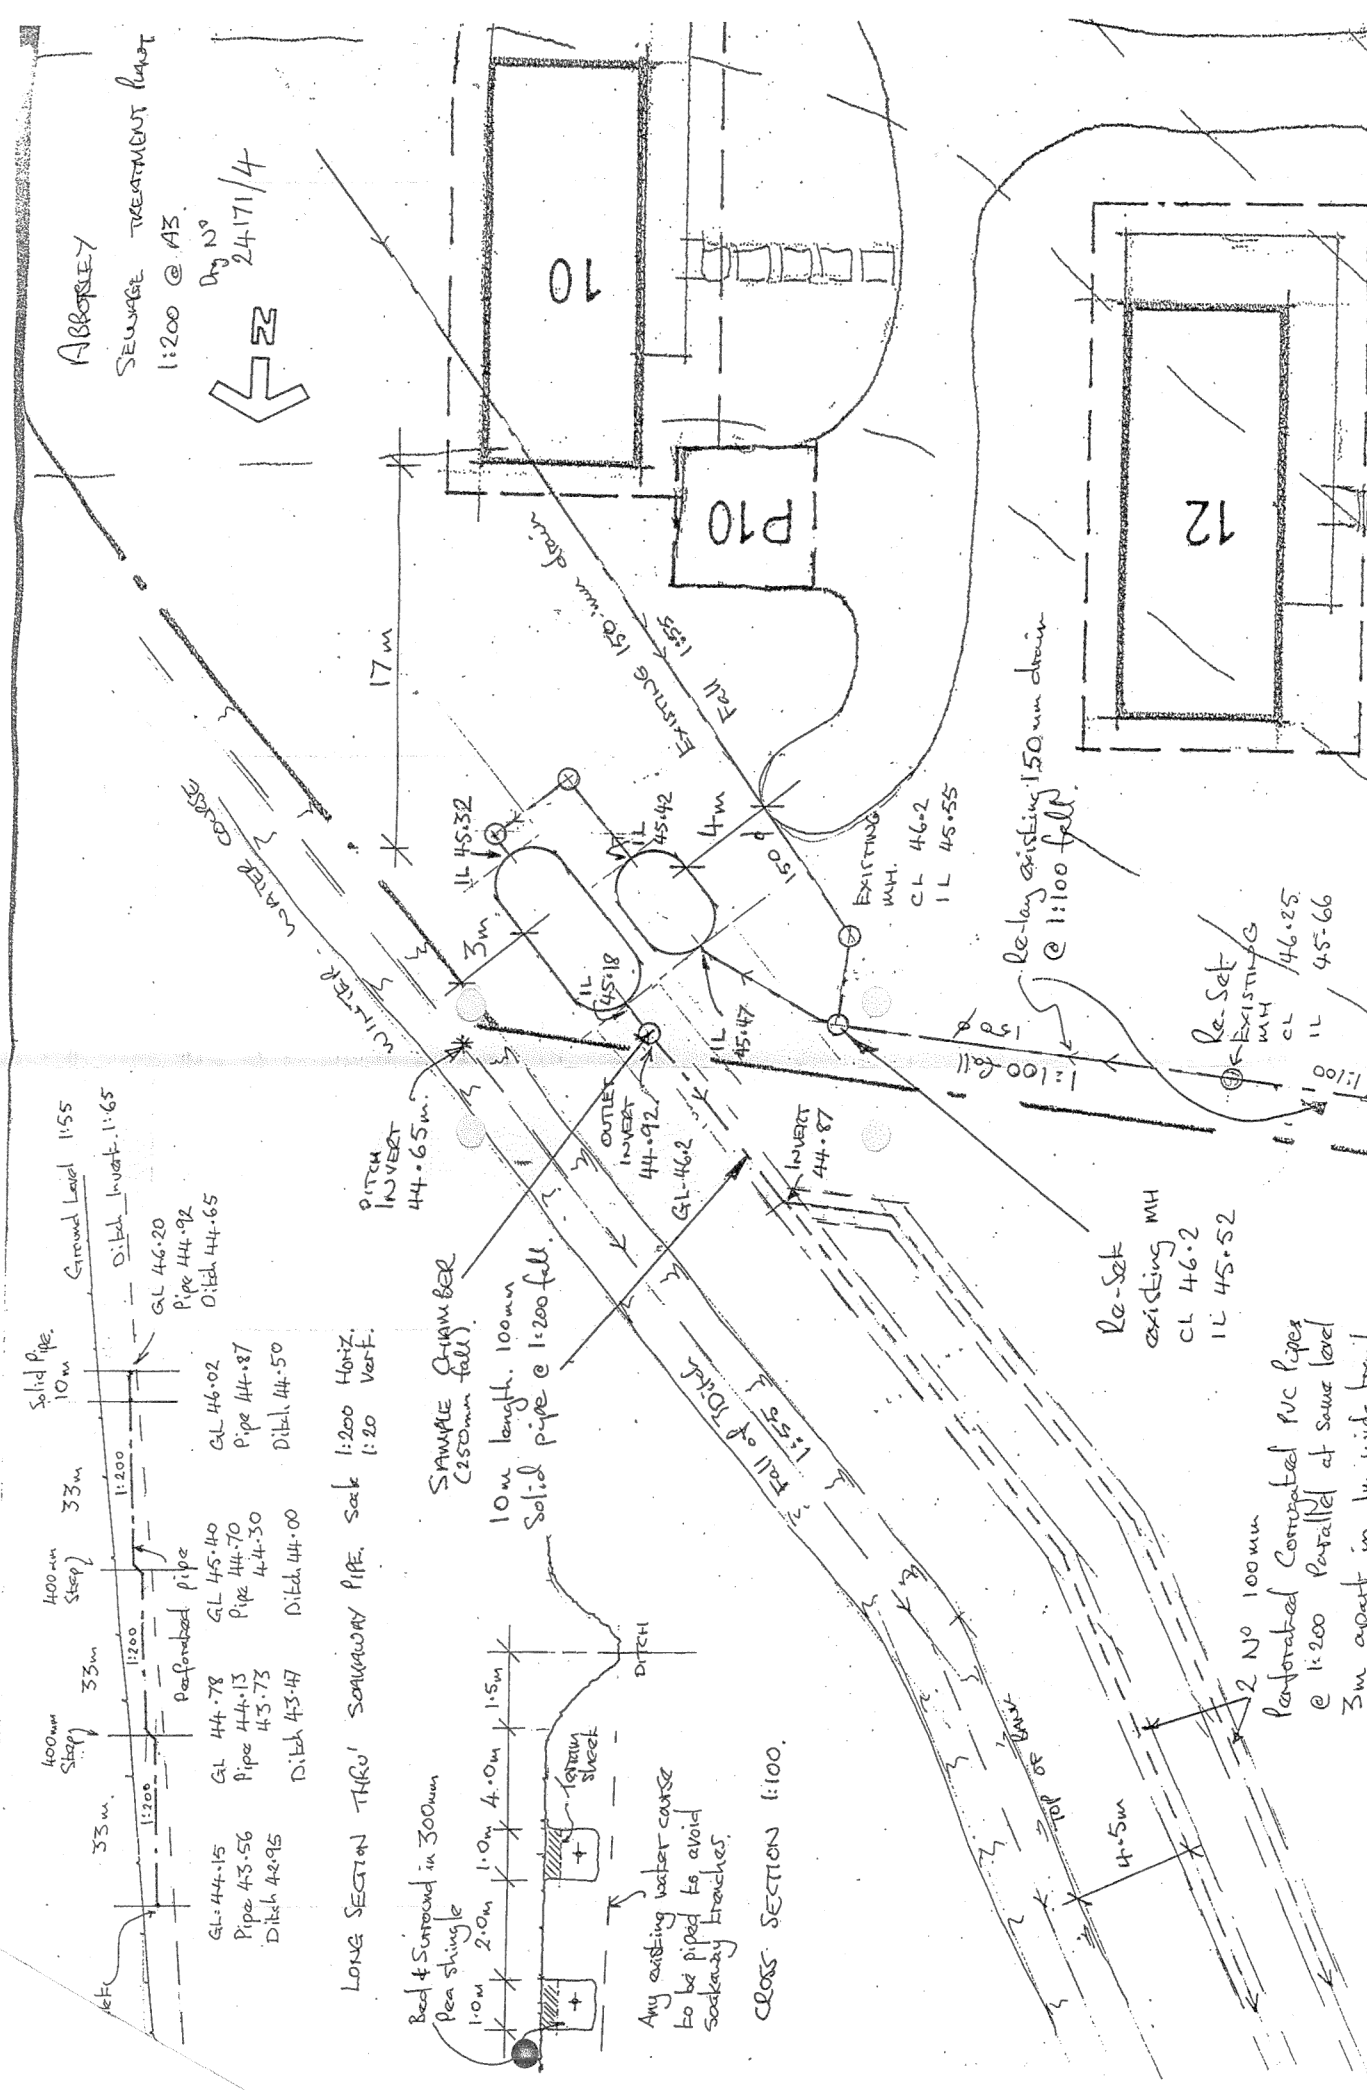
Dy No
24-171/4

LONG SECTION THRU SODKWAY PIPE. SAK 1:200 Horiz. 1:20 Vert.

2 No 100mm
Perforated Corrugated PVC Pipes
@ 1:200 Parallel at same level
3m apart in 1m wide trenches.

Bed & surround in 300mm
Pea shingle
1.0m 2.0m 1.0m 4.0m 1.5m
Any existing water course
to be piped to avoid
sodkway branches.

Re-Set
existing MH
CL 46.2
IL 45.52

Re-lay existing 150mm drain
@ 1:100 fall

Re-Set
EXISTING
MH
CL 46.25
IL 45.66
